SHEPPARD MEYERS DAM

PHASE I INSPECTION REPORT

NATIONAL DAM SAFETY PROGRAM

Name of Dam: SHEPPARD & MYERS
State Located: PENNSYLVANIA
County Located: YORK
Stream: SOUTH BRANCH CONEWAGO CREEK
Date of Inspection: MARCH 30, 1978

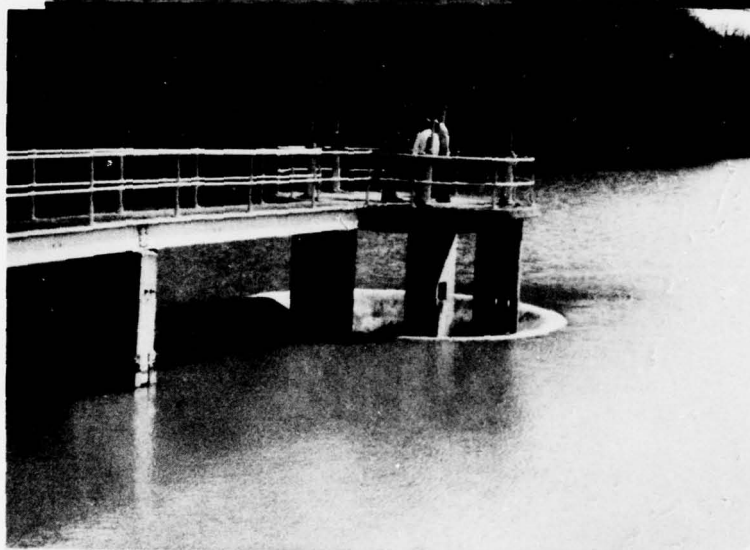
Morning Glory
Intake Tower

This structure was in good condition except for the base of one manual crank for the sluice gate at elevation 686.0. The base is broken loose from the concrete and the gate probably cannot be operated. The inside of the morning glory was not inspected (Plate III).

The opening to the spillway is obstructed by the supports for the valve operating platform which are also the concrete enclosures for the five valve stem risers. Floating drift could catch on these obstructions and reduce the capacity of the spillway.

The slab movement in the spillway is the most serious failure of the structures. The cracked base of the stand on the intake tower could cause water loss if the gate would be used and could not be closed.

1. The owner should repair the spillway slab as soon as the water level will permit.
2. Owner should investigate the need and feasibility of installing a trash boom around the morning glory.
3. Repair gate lift.

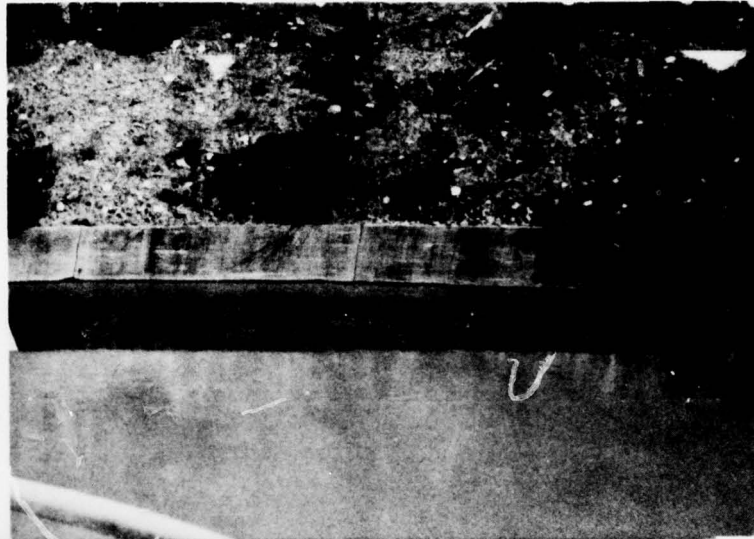
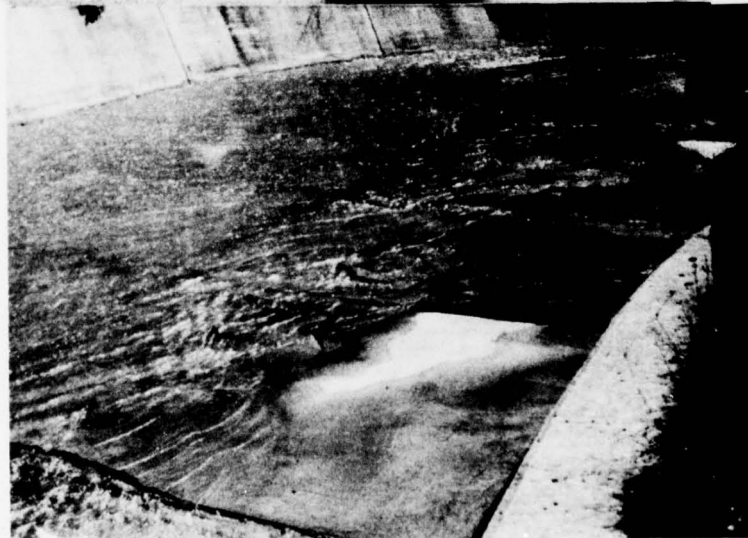
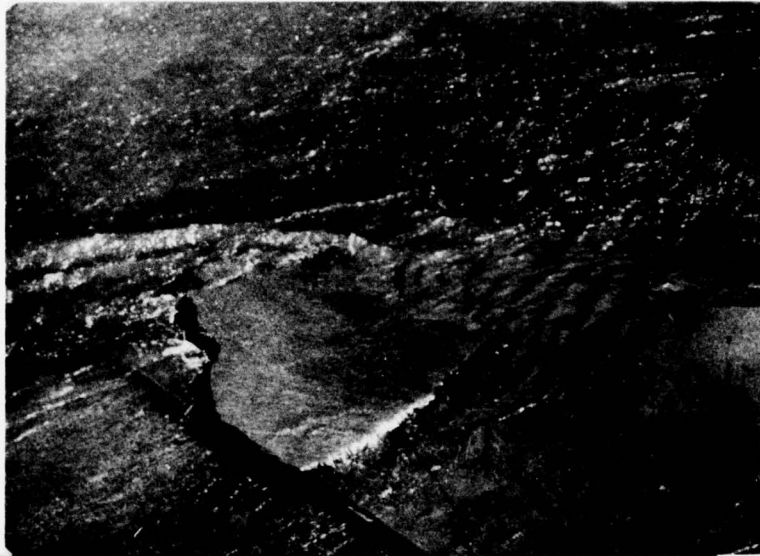
The spillway crest and walls are in good condition, except a few minor cracks. The spillway slab shows deterioration. The two inch layer applied in 1963 has disintegrated over a large area and was probably not sufficiently anchored and bonded to the old slab. One slab about 200 feet downstream from the crest has been seriously displaced and should be repaired as soon as possible (Plates IV and V, Appendix D).

The spillway slab is 12 inches thick, placed on the rock surface. No drain system is indicated. The spillway walls are placed on 1/2H to 1V and are 18 inches thick and poured against the rock cut. Rock anchors are not indicated, on the drawings. Weep holes are located at the bottom of the walls. No distress or displacement was found in any of the spillway walls. The absence of a drainage system under the spillway slab could have caused the slab movement.

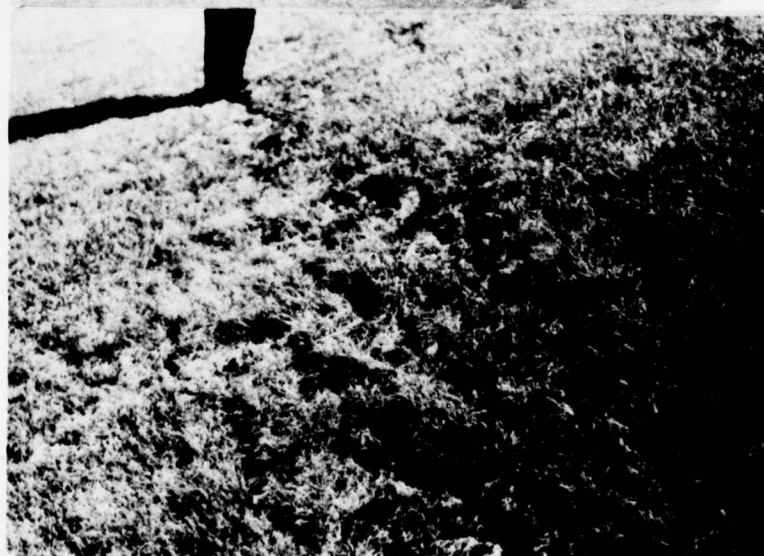
Embankment Slope
'Mole Activity'

The dam embankment is maintained in excellent condition. There was no evidence of seepage on the slope and the toe was dry and hard. A few places on the embankment indicated mole activity under the snow during the winter. Downstream of the embankment is a large wet area which reportedly dries out in the summertime (Plate VI). This wet area is probably caused by a spring and the area has been tiled. The area is about 100 feet from the toe of the embankment. There was no evidence of any cracking, sloughage or visually detectable settlement in the embankment. The riprap on the slope and the dam crest road is in excellent condition.
